AGENDA

HISTORIC PRESERVATION ADVISORY BOARD MEETING
CITY HALL, 385 SOUTH GOLIAD, ROCKWALL, TEXAS
NOVEMBER 21, 2024 IN THE CITY COUNCIL CHAMBERS AT 6:00 PM

Hold a public hearing to discuss and consider a request by Annette Lall on behalf of HIS Covenant Children, Inc. for the approval of a Certificate of Appropriateness (COA) for exterior alterations for a Landmark Property being a 0.689-acre tract of land identified as a portion of Lots A & B, Block 2, Griffith Addition, City of Rockwall, Rockwall County, Texas, zoned Downtown (DT) District, addressed as 303 E. Rusk Street, and take any action necessary.

H2024-025: Certificate of Appropriateness (COA)
for 303 E. Rusk Street

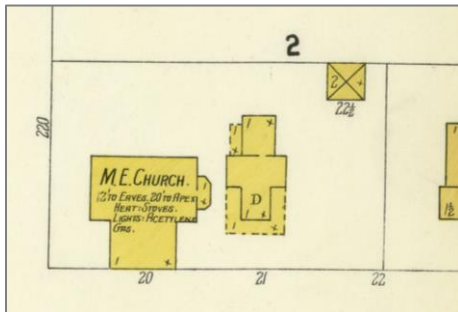
FIGURE 1: 1900 SANBORN MAPS

The subject property was annexed prior to 1900 based on the October 1900 Sanborn Maps. According to the Rockwall Central Appraisal District (RCAD), existing on the subject property is a 3,980 SF *Office Building* and a 4,209 SF *House of Worship*. The *House of Worship* was constructed in 1913, and -- based on the 1934 Sanborn Maps -- the *Office Building* was constructed after 1934.

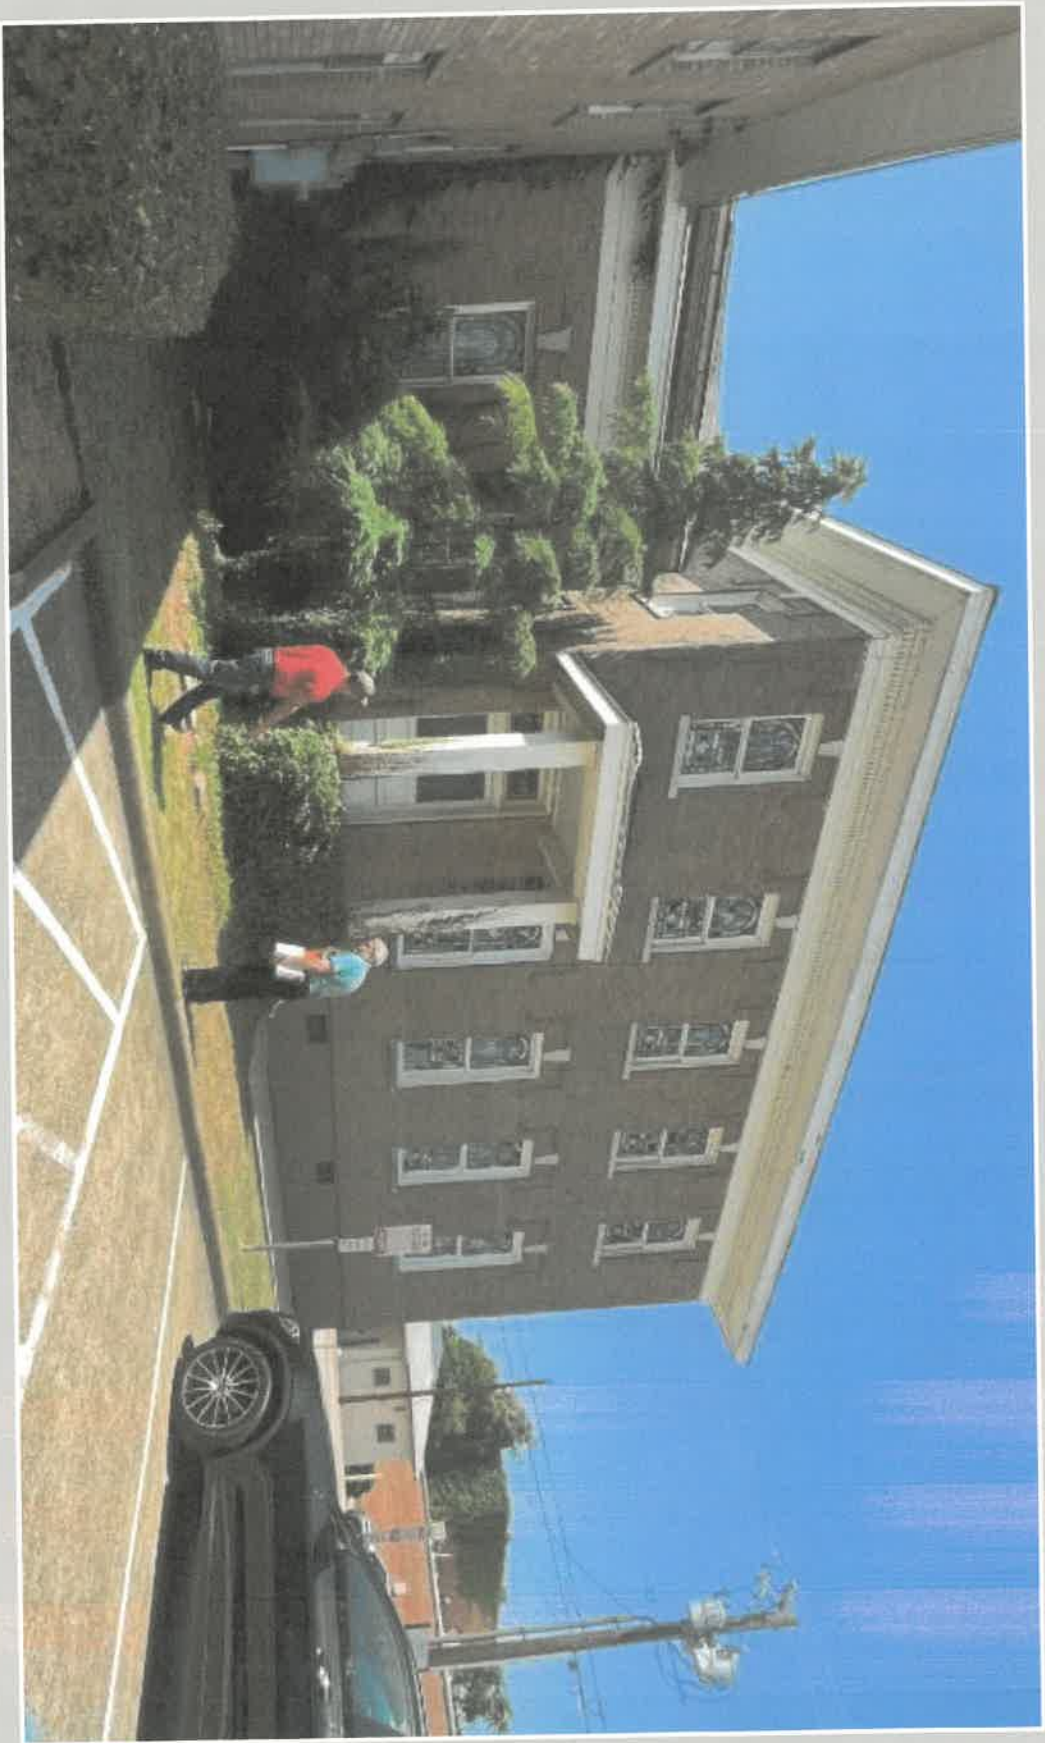
North Side Church
14 Windows

North

1. Replace 73 windows with plain glass/vinyl - timeline 8-10 wks manufacture - installation 7 days
2. Remake stain glass - done in sections - timeline June 2025 - June 2027 - See attached
3. Photos of examples of final look inside/outside. Stain glass installed inside.
4. Replace and install 4 double doors, 2 single doors/fiberglass - timeline manufacture 8-10 weeks - installation - 5 days - see picture of door attached.
5. Replace + make molding - 2-3 months, installation 7 days.

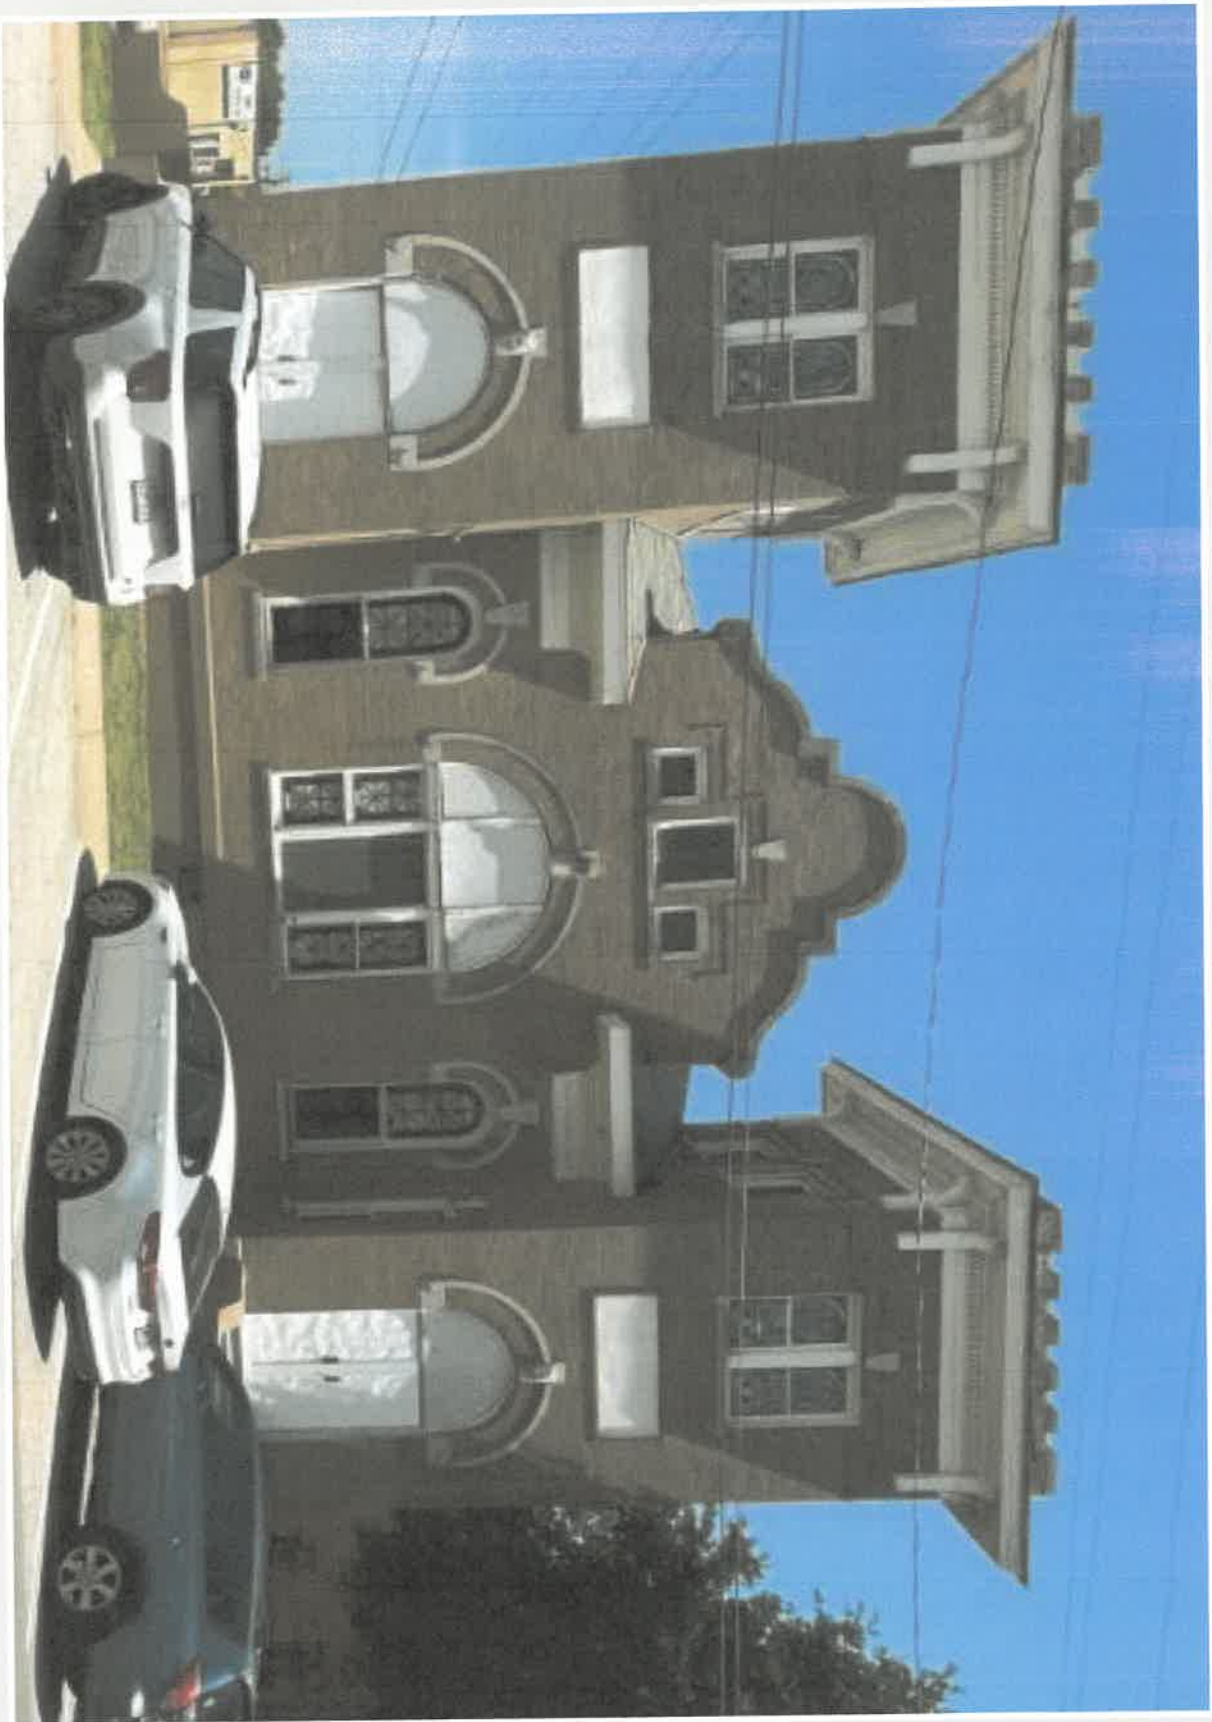
South Side Church

18 Windows

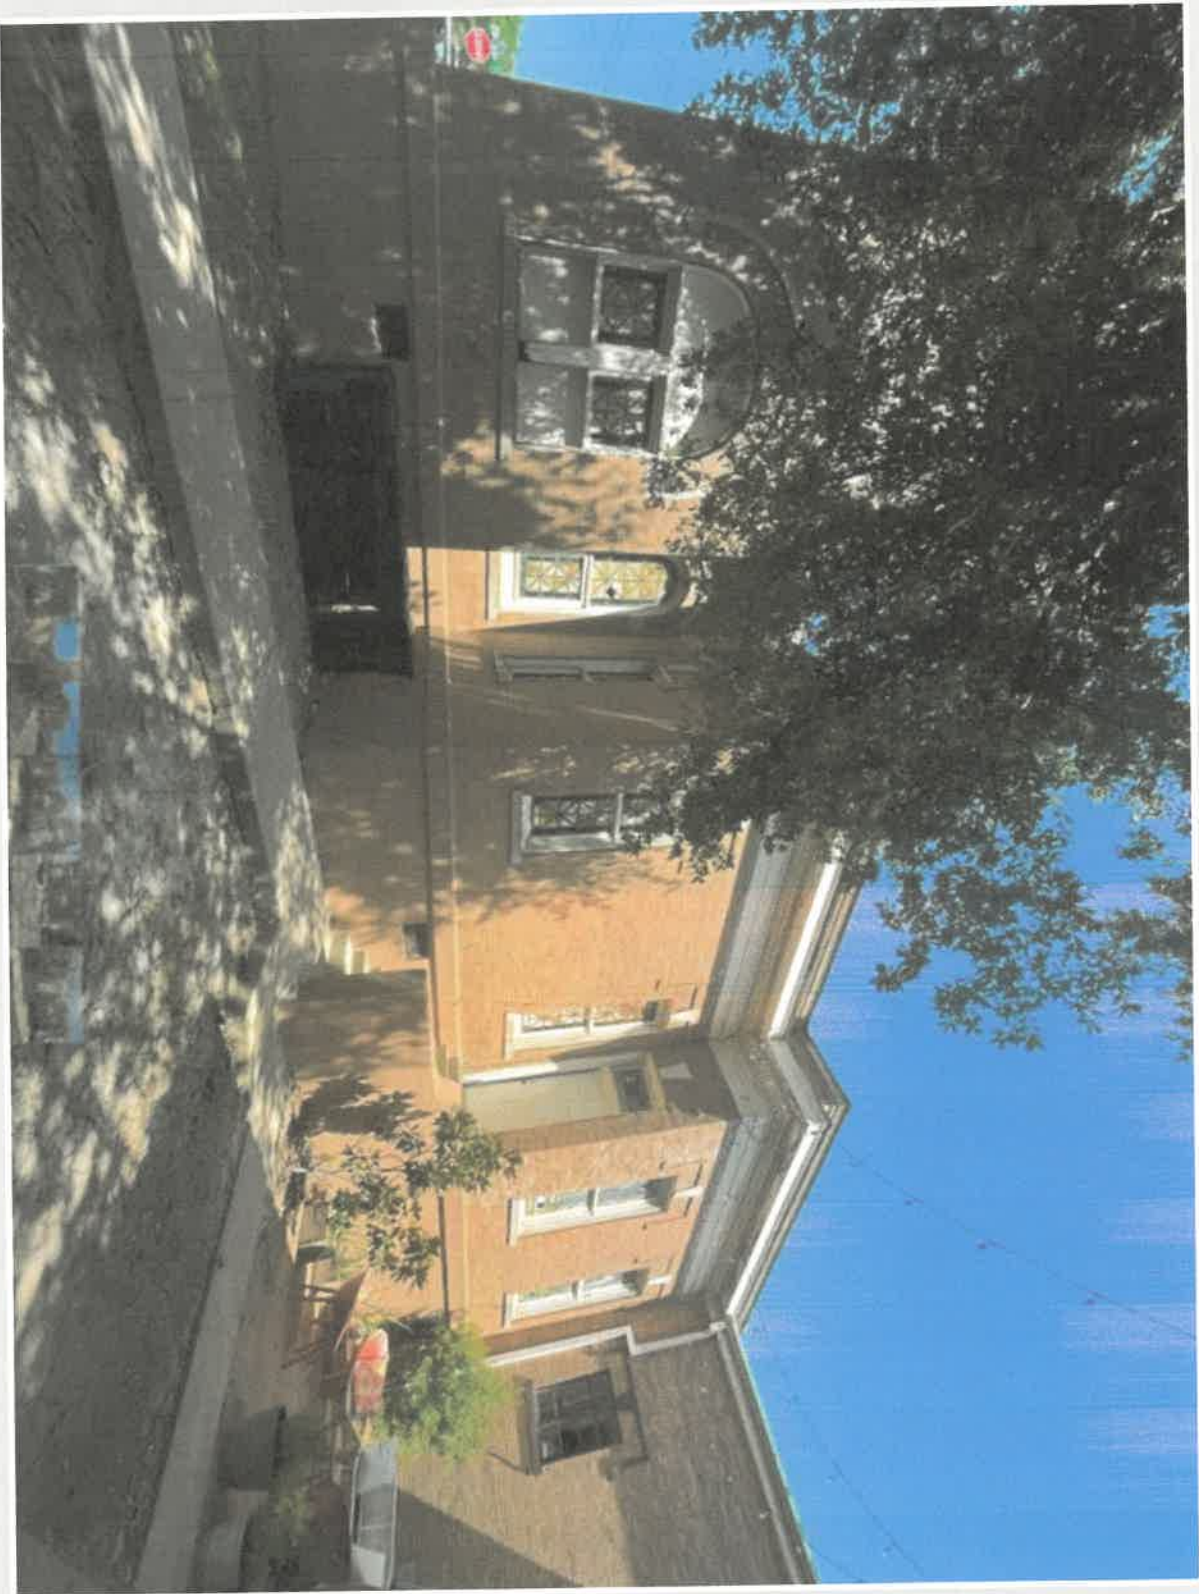
East Side Church

15 Windows

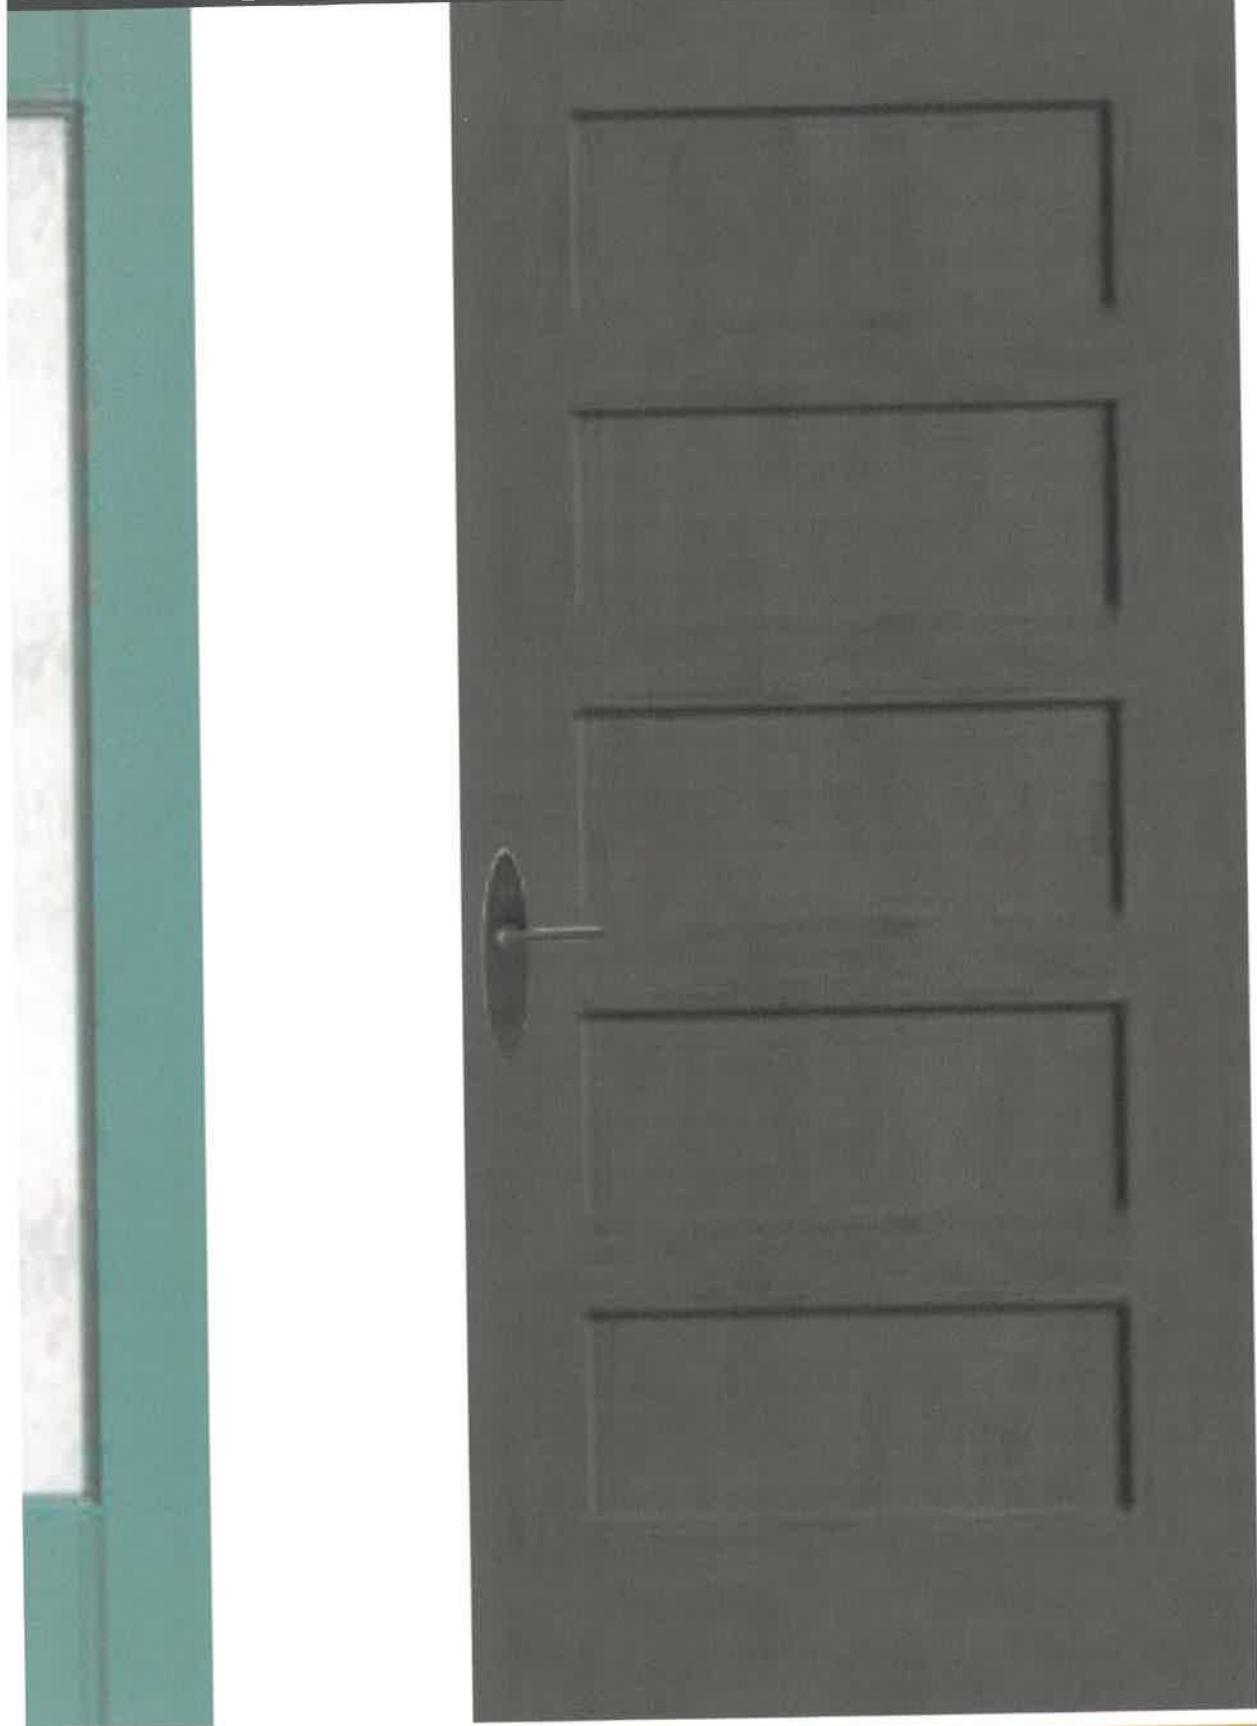
CCA1150 / Classic Craft
Six Panel

- (3) *Item 3: Replacing Doors*. According to Section 07(C)(7), of Appendix D, *Historic Preservation Guidelines*, of the Unified Development Code (UDC), "(t)he overall relationship of the size, width, height and number of doors and windows on the exterior building facades should be typical of the style and period of the structure." In this case, the applicant is requesting to replace six (6) doors that are *not* original to the building, and exhibit physical wear and water damage. Based on the time period in which the main sanctuary was constructed (*i.e.* 1913) the original doors for the church would have been of wood construction. In addition, the image in *Figure 4* depicts a windowed door that most likely incorporated stained glass matching the windows of the main sanctuary. The door being proposed by the applicant, is a large paneled, contemporary door that appears to be similar to either Craftsman or Mid-Century Modern architecture. Both of these styles would *not* be characteristic of the time period or architectural style (*i.e.* *Spanish Revival* or *Mission*) of the main structure. In addition, the proposed door is of fiberglass construction, which would not be characteristic of the materials that would have been

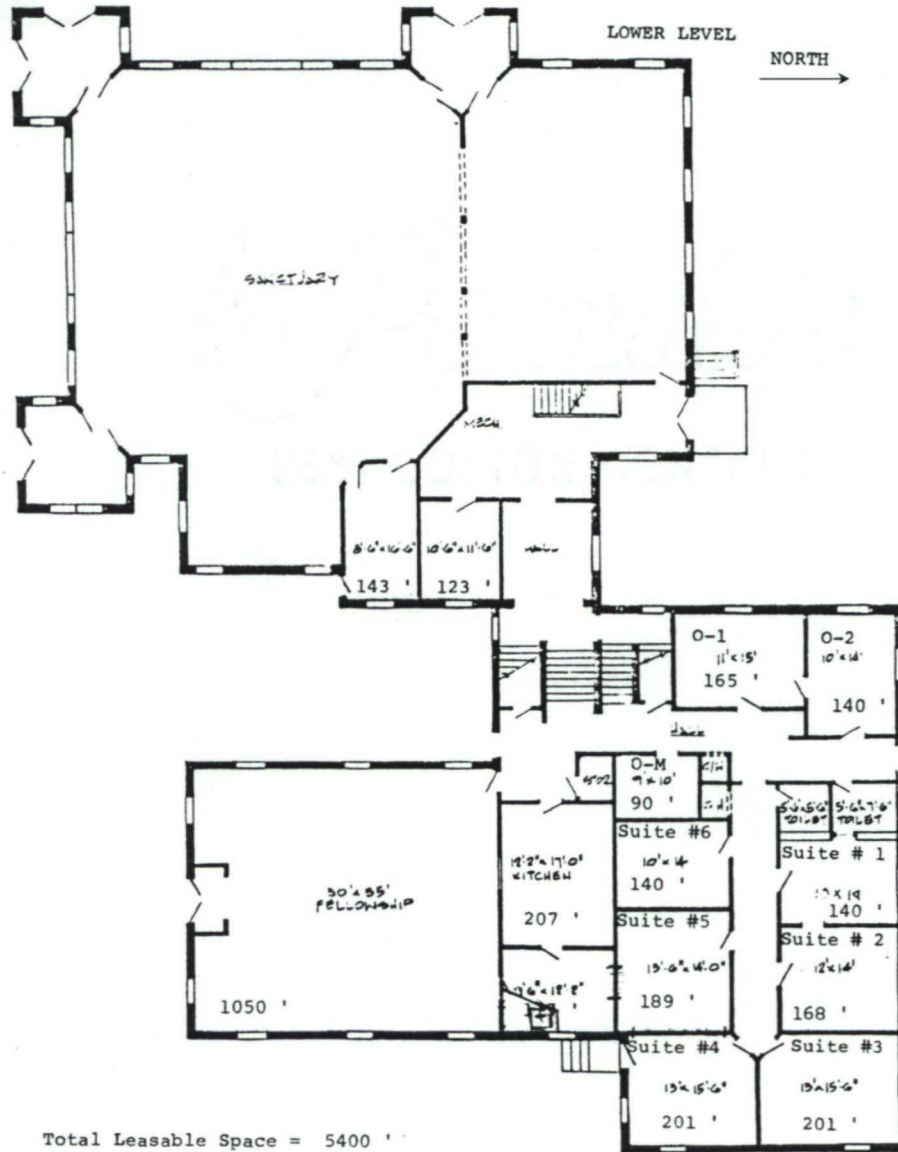
LOWER LEVEL PLAN

Total Leasable Space = 5400'
Lower Level = 2806'
Upper Level = 2594'
Halls, Baths, Storage Approx. 1600

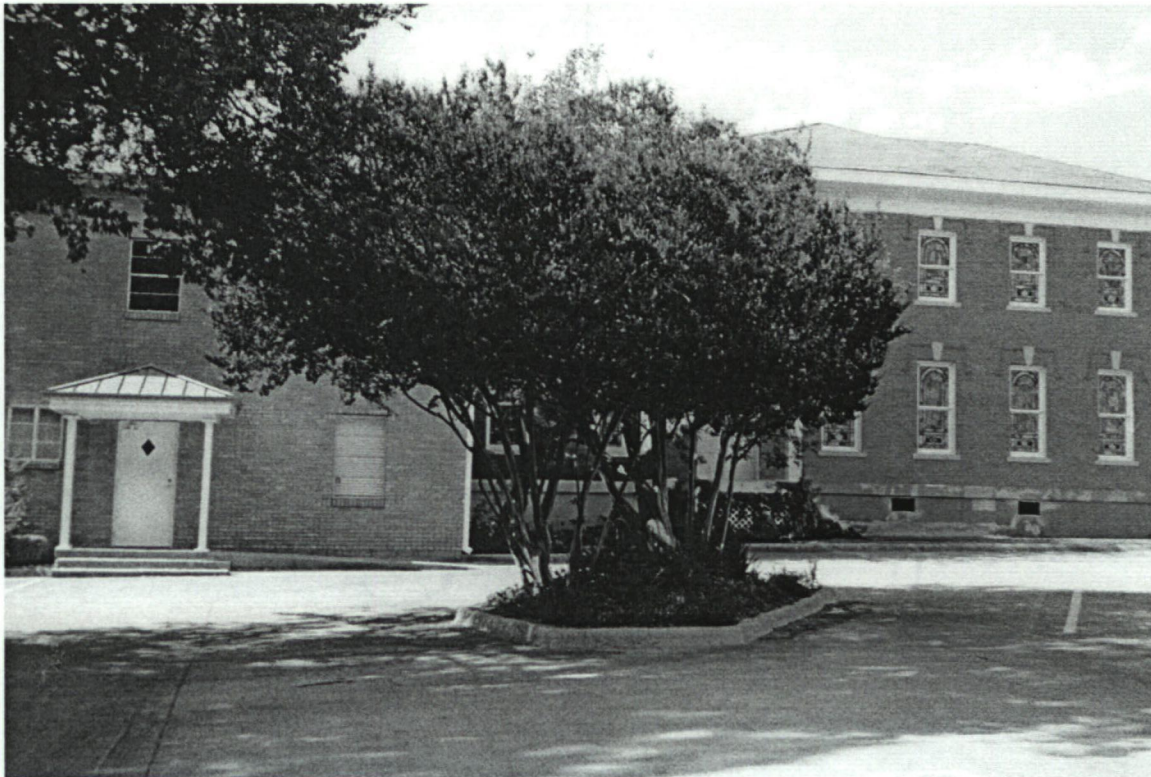
North elevation, showing addition on left, original structure on right

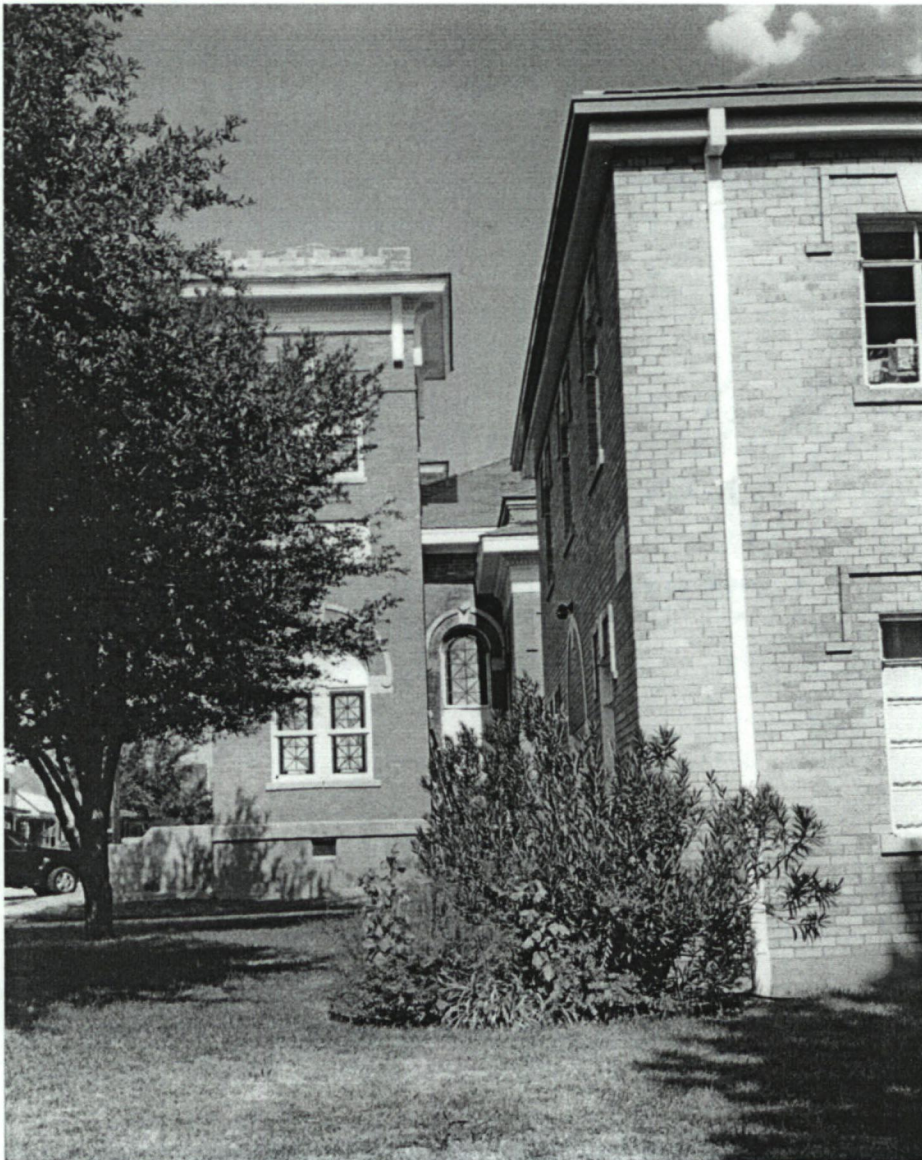
East façade, including SE tower of original structure on left and addition on right

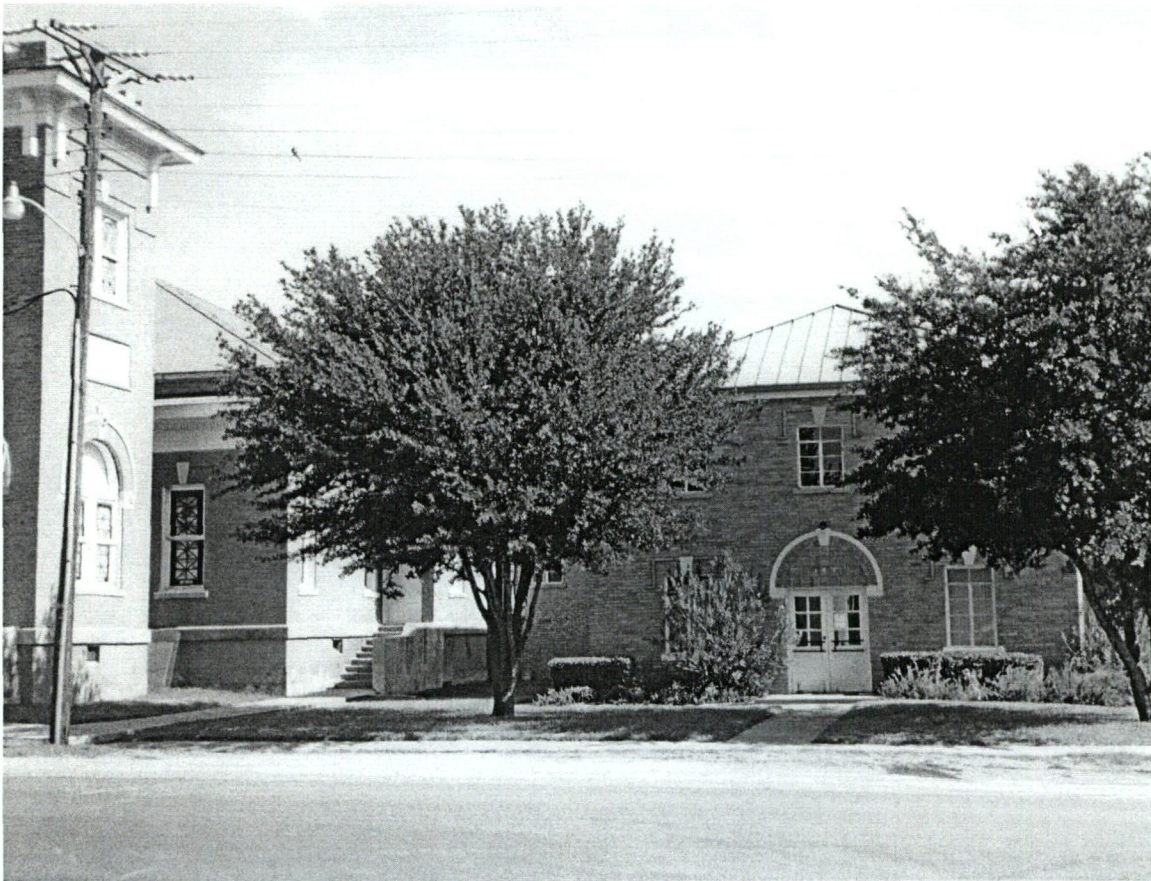
South elevation of addition, with original building on left

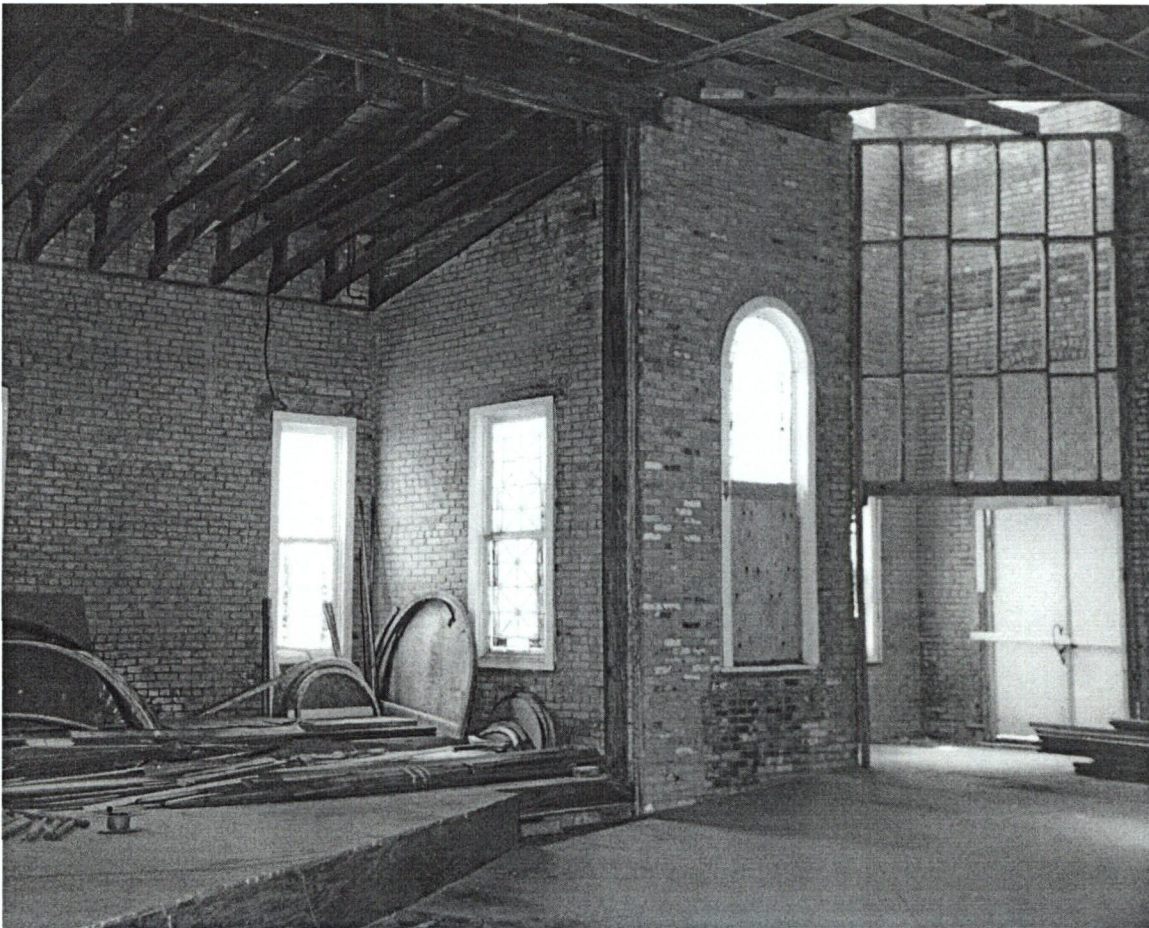
Condition of sanctuary interior in 2006, showing raised area on left and corner tower entry on right.

The interior of the sanctuary space is vacant and in various states of repair. Brickwork, rafters, wall framing, and concrete floors remain exposed while restoration proceeds. The original layout of the sanctuary is unknown, but many elements indicate it may have been based on the Akron Plan. Onsite investigations, although not complete, point to rolling doors that came down to separate classrooms from the larger sanctuary space.
